Brief:

- Remove old cladding as it was the incorrect material for external use (MDF)
- Bring the overall design upto code as this external wall leaked each time it rained
- Create a front facade design that looks more inviting
- Close off the garage opening

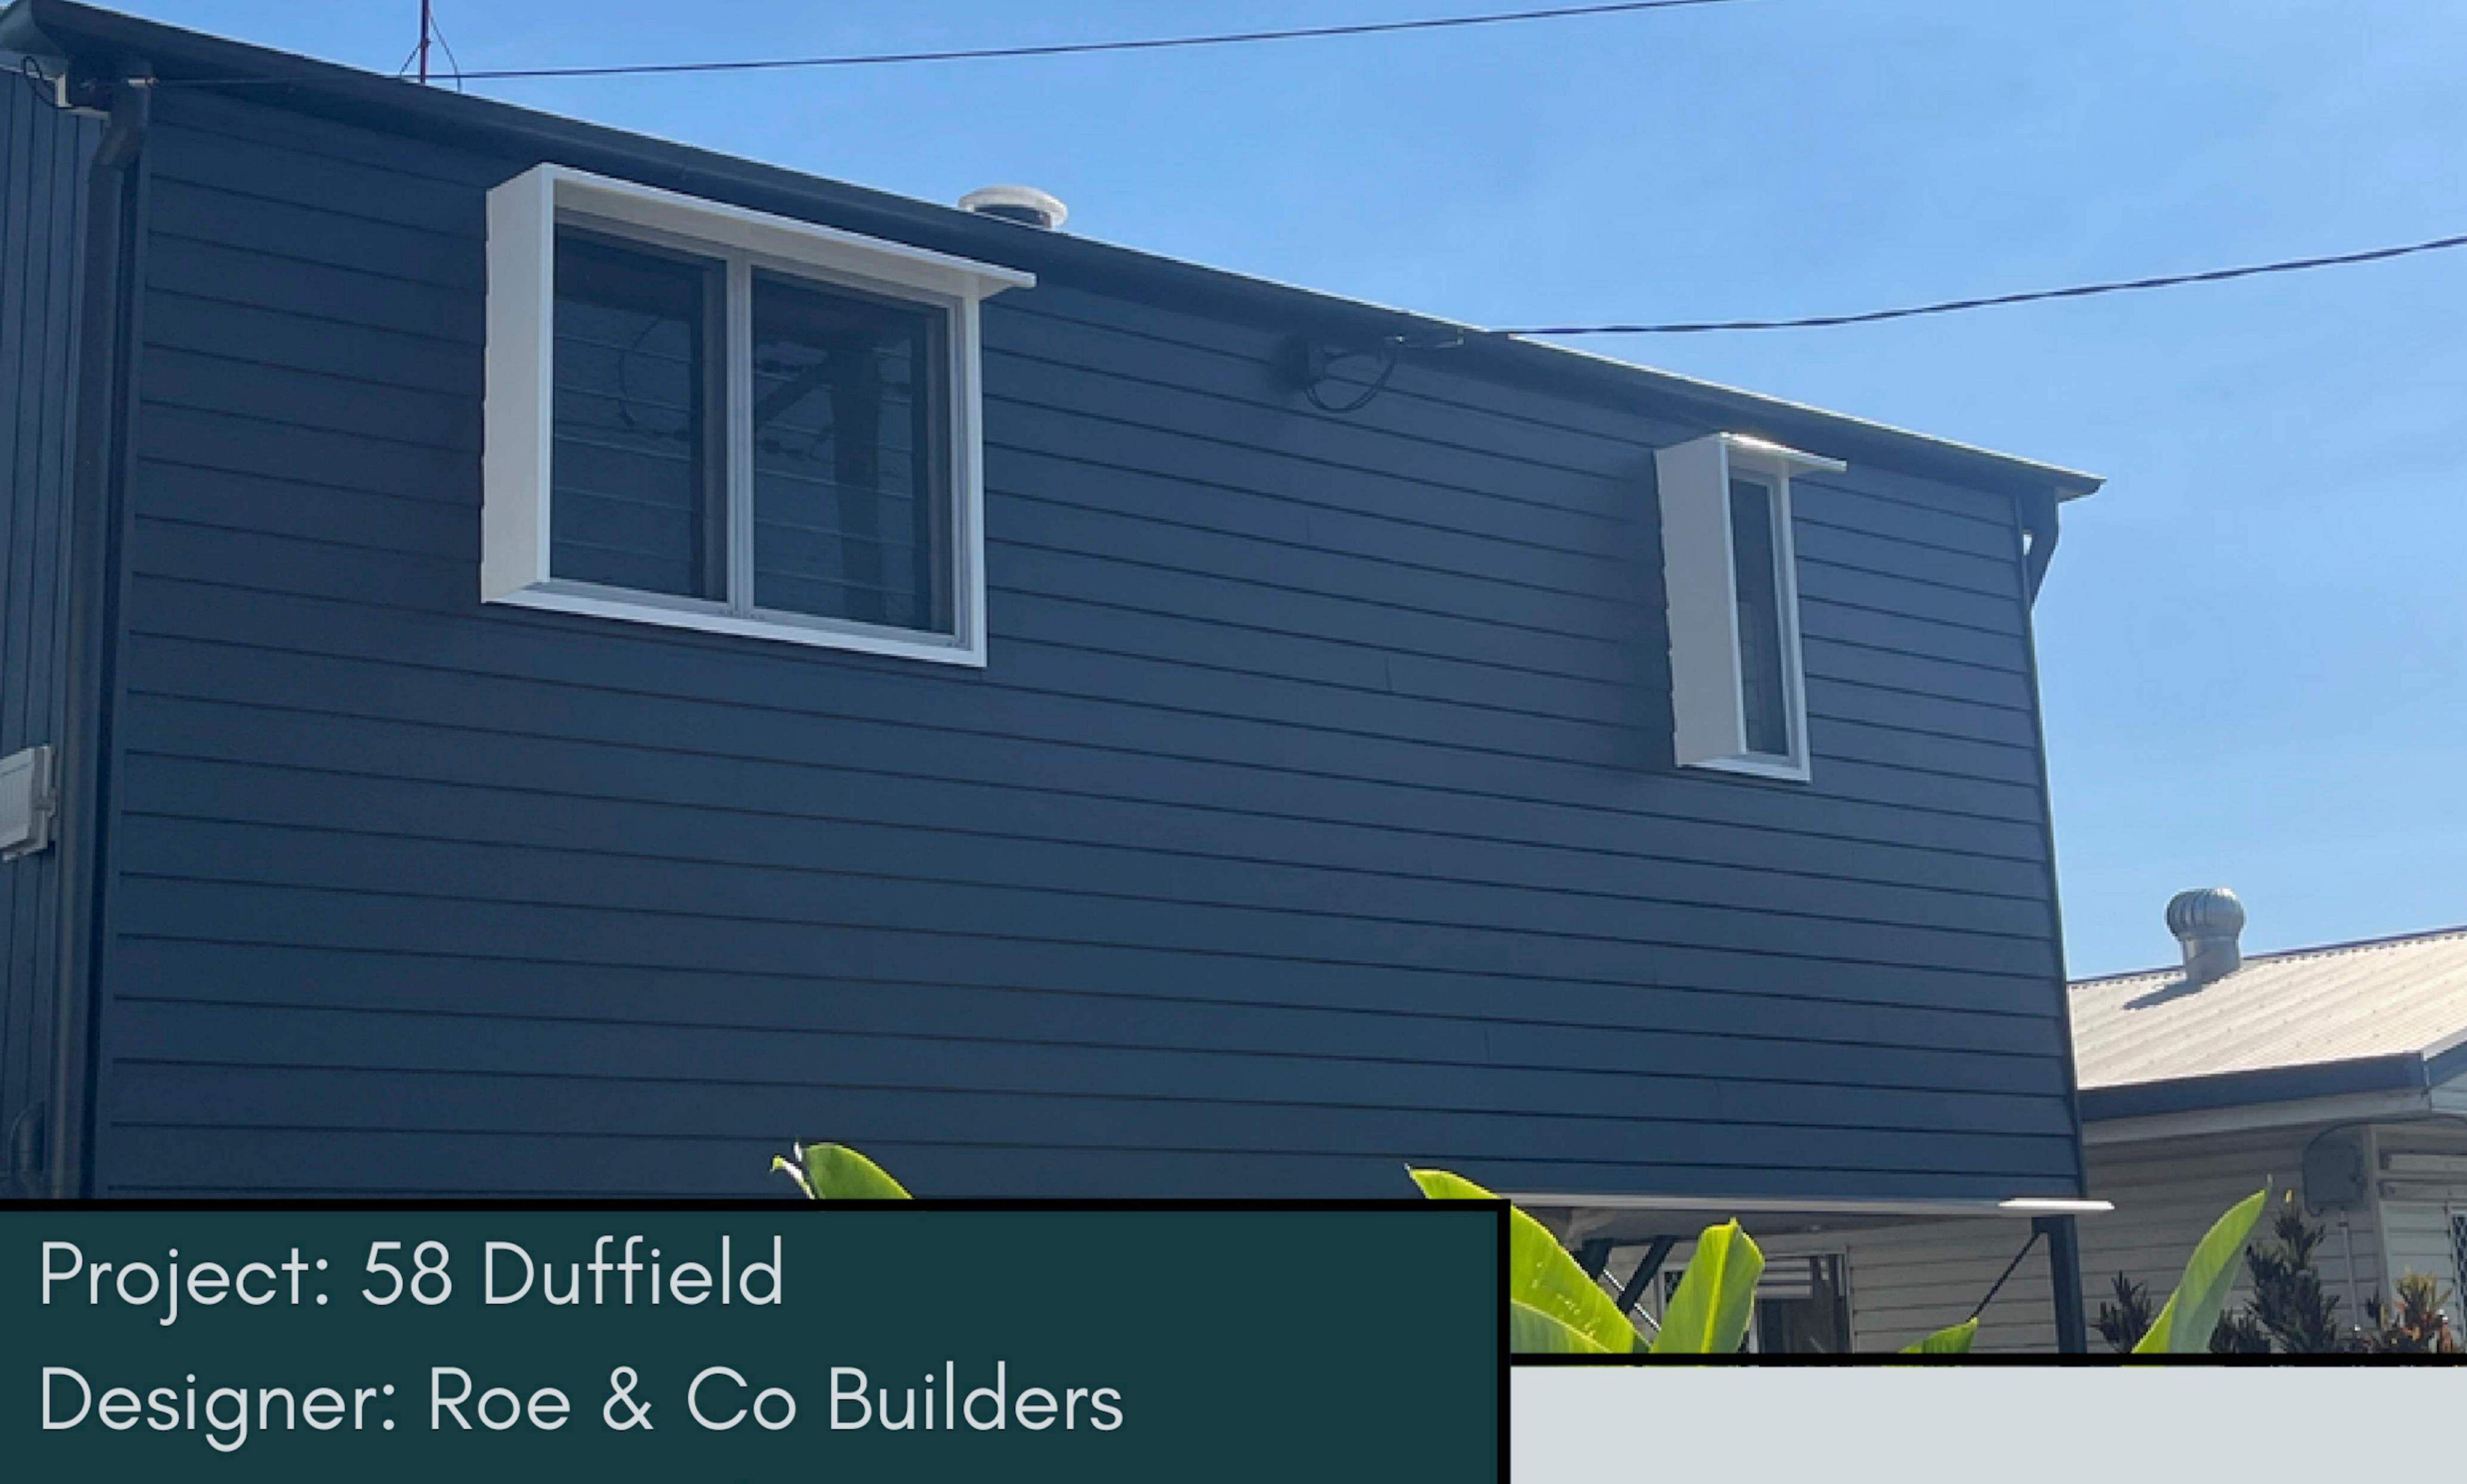
- Great Access and plenty of exposure on a busy road
- Power Lines had to be dropped in order to complete works safely
- Rotten Timber had to be replaced due to water build up and leaks

- Heka Hoods installed to top windows
- Dulux domino painted on cladding and lexicon painted on Window trims
- James Hardie PrimLine Newport Weatherboards
- Southern Star windows supplied lower window and screen
