Brief:

- Remove rotten Pine decking and Balustrade
- Replace Rotten Joists
- Install Merbau decking & balustrade to meet Australian Standards
- Remove Posts protruding through deck

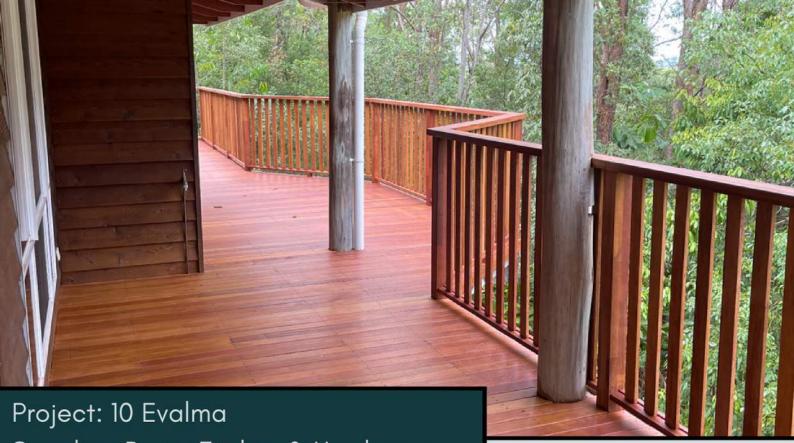
- Deck is 5m off the ground at its highest point
- Property was on a steep incline which meant extra difficulty for material delivery and waste removal

- 90 x 19mm Merbau Decking
- 140mm Merbau Top rail and 70mm slats for balustrade
- Hardwood Joists
- 90 x 90mm Merbau Posts
